A/C Compressor Warranty Return Analysis Report

Part #	471-1630	Qty.	2
Installer:	Art's Automotive		
Supplier:	Worldpac		
Vehicle:	2006 Honda Odyssey

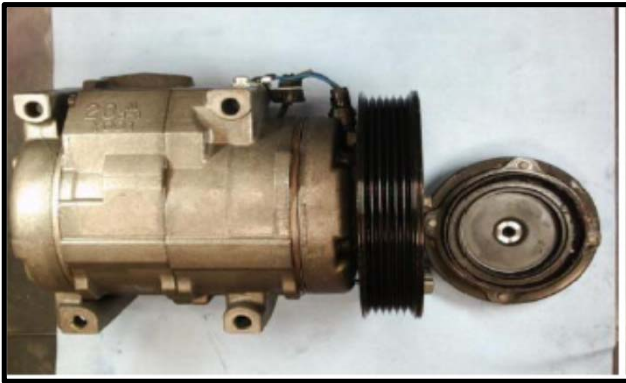
Unit #1

This compressor is a Honda reman service part. Compressor was seized as received, shaft did not spin, clutch had signs of high heat/friction and hub rubber was melted, consistent with compressor seizure. Compressor passed leak test. Recovered oil was yellow in color and very sticky, oil would be expected to be clear or green if dye was added. Dismantle of compressor revealed all components coated with a sticky substance and steel components had corrosion/rust. Missing seal caps would accelerate rust/corrosion but corrosion was excessive for a part less than 2 months old, even with no seal caps. This accelerated corrosion is common for compressor returns with sticky foreign material found in oil. Very little wear on internal components.

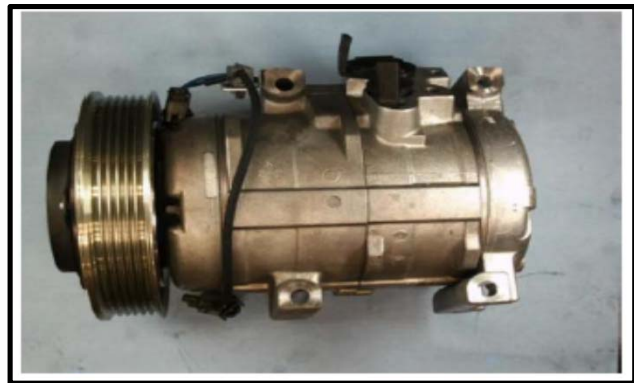
Unit #2

This compressor is a DENSO brand 471-1630. Compressor was seized as received, shaft did not spin, clutch had minor signs of high heat/friction consistent with compressor seizure. Compressor passed leak test. Recovered oil was yellow in color and very sticky, oil would be expected to be clear or green if dye was added. Dismantle of compressor revealed all components coated with a sticky substance. Pistons were difficult to remove because piston shoes were stuck in swash plate. Pistons, shoes, and swash plate had very little wear. Some corrosion on valve plates, consistent with compressor returns with sticky foreign material.
