A/C Compressor Warranty Return Analysis Report

Part #	471-1630	Qty.	2
Installer:	Art's Automotive		
Supplier:	Worldpac		
Vehicle:	2006 Honda Odyssey

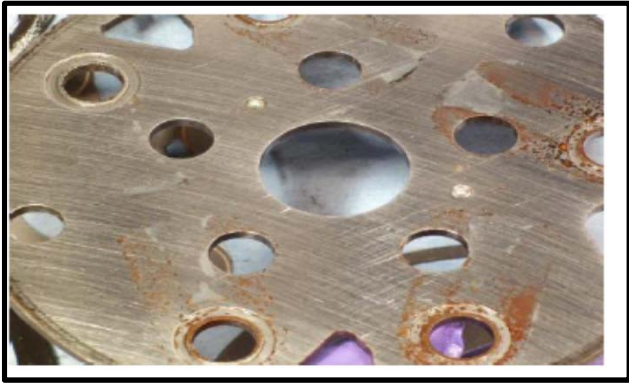
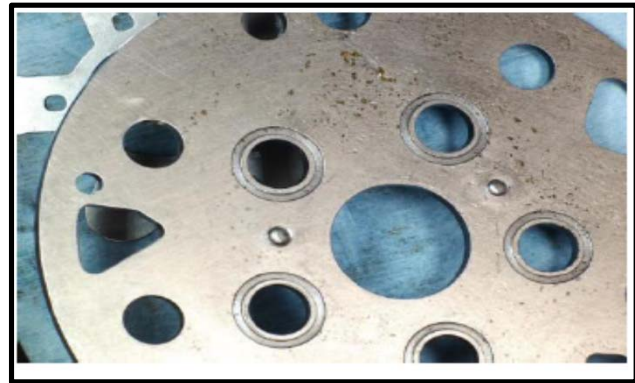
Housings

This compressor is a Honda reman service part. Compressor was seized as received, shaft did not spin, clutch had signs of high heat/friction and hub rubber was melted, consistent with compressor seizure. Compressor passed leak test. Recovered oil was yellow in color and very sticky, oil would be expected to be clear or green if dye was added. Dismantle of compressor revealed all components coated with a sticky substance and steel components had corrosion/rust. Missing seal caps would accelerate rust/corrosion but corrosion was excessive for a part less than 2 months old, even with no seal caps. This accelerated corrosion is common for compressor returns with sticky foreign material found in oil. Very little wear on internal components.

This compressor is a DENSO brand 471-1630. Compressor was seized as received, shaft did not spin, clutch had minor signs of high heat/friction consistent with compressor seizure. Compressor passed leak test. Recovered oil was yellow in color and very sticky, oil would be expected to be clear or green if dye was added. Dismantle of compressor revealed all components coated with a sticky substance. Pistons were difficult to remove because piston shoes were stuck in swash plate. Pistons, shoes, and swash plate had very little wear. Some corrosion on valve plates, consistent with compressor returns with sticky foreign material.

Compressor seized due to unknown foreign material which caused internal parts to stick together to the degree that it prevented the shaft from spinning. A contaminant in the system would be consistent with multiple compressor replacements within two weeks of each other.
